Darrington Collaborative
FS 2060 - CLEAR CREEK ROAD
T 31 N - R 10 E
Snohomish County
2016

Draft 6-17-13

Clear Creek Riparian Restoration Project: Forest Service Roads #2060 & 2065

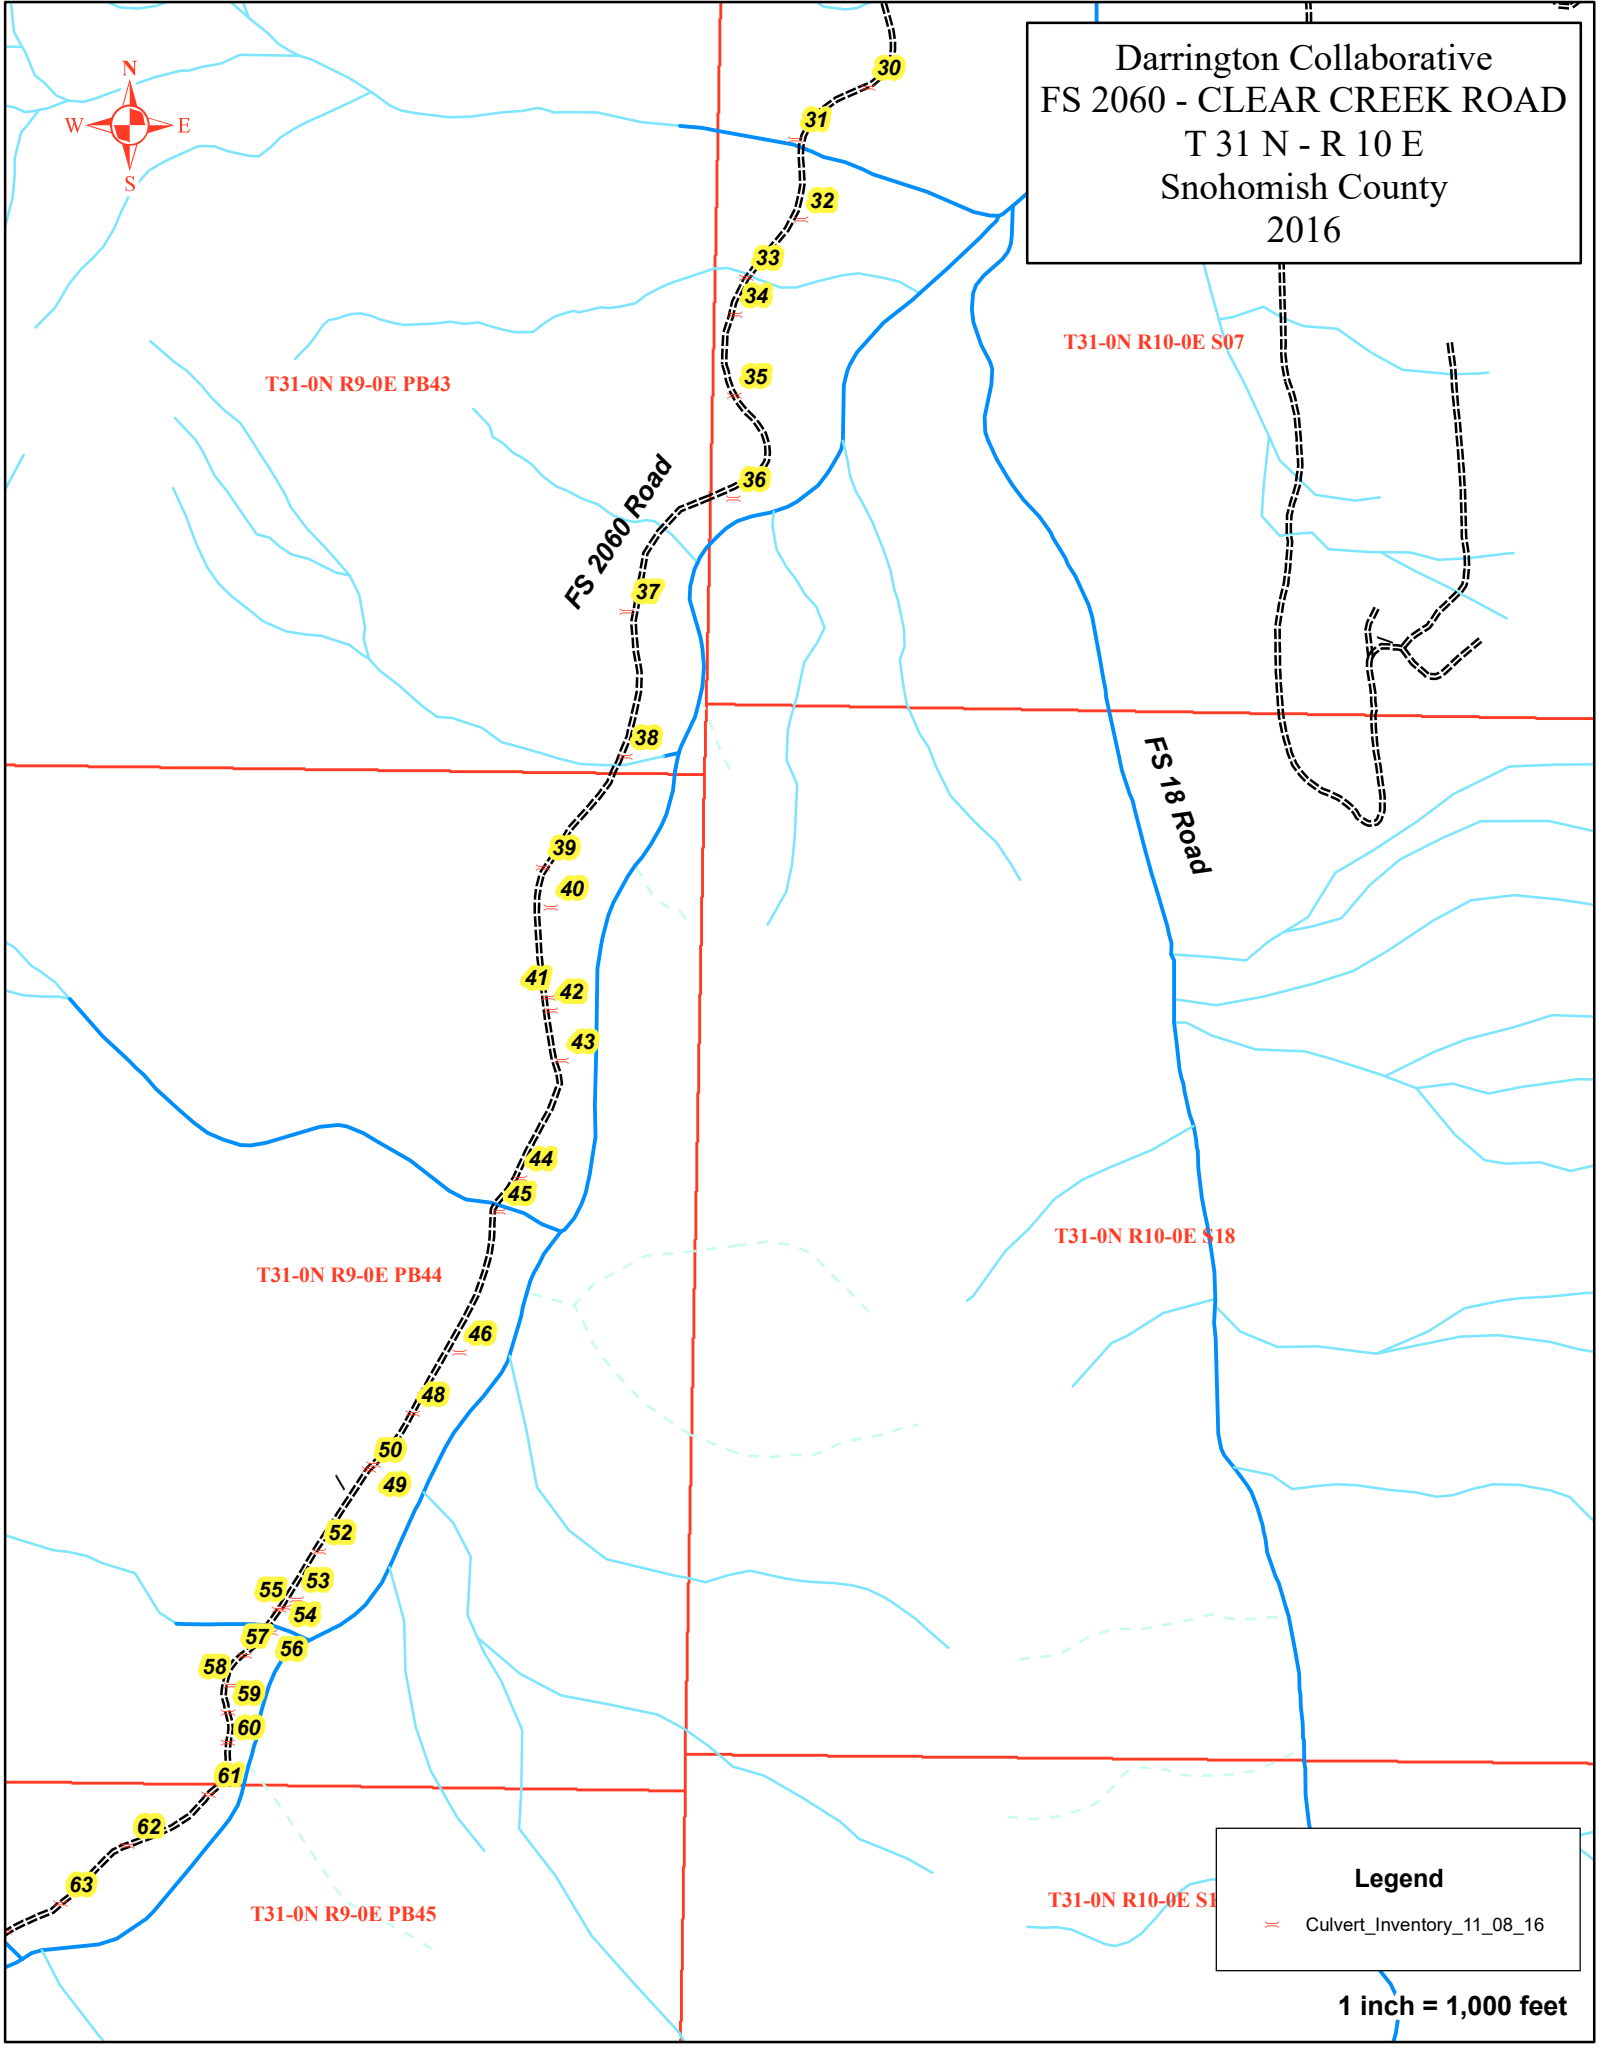
POINT	Feature	H2O_Type	In_DIA	Connect to Stream	Length	Observed
0	seep	s			0	runs into & down ditch
1	CMP	R	18	N	0	holes in bottom of outlet
2	CMP	N	18	Y	0	pirating road water
3	CMP	S	18	Y	0	
4	CMP	R	18	N	0	weak ditch block
5	CMP	R	18	N	0	runs to Clear Creek
6	CMP	S	18	Y	0	
8	CMP	R	18	Y	0	
9	CMP	N	30	Y	0	outlet mostly buried
10	CMP	N	18	Y	0	
11	CMP	R	18	N	0	
12	CMP	N	18	Y	0	
13	CMP	R	18	N	0	
14	CMP	R	18	N	0	
15	CMP	R	18	N	0	
16	CMP	S	18	N	0	
17	FORD	N	ROCK	Y	0	
18	CMP	R	18	N	0	
19	FORD	N	ROCK	Y	0	
20	PP	R	18	N	0	
21	CMP	N	60	Y	0	potential F water downstream
22	CMP	R	18	N	0	
23	PP	N	24	Y	0	
24	CMP	N	24	N	0	
25	CMP	R	18	N	0	outflow blocked
26	wash	N			0	
27	PP	N	24	Y	0	
28	CMP	R	18	N	0	
29	CMP	N	18	Y	0	
30	CMP	R	18	N	0	
31	FORD	F	CONC	N	0	asbestos creek concrete ford
32	CMP	S	18	Y	0	
33	CMP	R	18	N	0	
34	CMP	S	18	N	0	
35	CMP	R	18	N	0	
36	CMP	R	18	Y	0	
37	CMP	R	18	N	0	
38	CMP	R	18	N	0	
39	CMP	R	18	N	0	
40	CMP	S	24	N	0

POINT	Feature	H2O_Type	In_DIA	Connect to Stream	Length	Observed
46	CMP	R	24	N	0	
47	CMP	S	24	N	0	
48	CMP	N	36	Y	0	
49	CMP	S	36	N	0	
50	CMP	N	24	Y	0	
51	SURFACE				0	
52					0	
53	CMP	N	36	N	0	
54	CMP	N	24	Y	0	potential F water
55	CMP	F	48	N	0	undersized, H2O flows under
56	CMP	N	36	N	0	undersized
57	CMP	R	18	N	0	
58	CMP	N	24	Y	0	
59	CMP	S	18	N	0	
60	CMP	S	24	Y	0	
61	PP	F	36	Y	0	potential F above culvert
62	CMP	F	18	Y	0	undersized
63	CMP		24	Y	0	potential F water
64	PP	N	36	N	0	
65	CMP	N	60	N	0	
66	CMP	N	24	N	0	
67	CMP	S	18	N	0	
68	CMP			Y	0	
69	CMP	N	30	N	0	
70	PP	N	24	N	0	
71	CMP		24	N	0	
72	CMP	N	24	Y	0	
73	CMP	N	24	N	0	clean catchment basin
74	CMP	N	24	Y	0	plugged & perched
75	CMP	S	24	N	0	
76	CMP		24	N	0
